DRAFT ENVIRONMENTAL ASSESSMENT NOKOMIS ROAD BRIDGE AT TENMILE CREEK LANCASTER, DALLAS COUNTY, TEXAS SECTION 14 EMERGENCY STREAMBANK EROSION PROTECTION

DRAFT FINDING OF NO SIGNIFICANT IMPACT NOKOMIS ROAD BRIDGE AT TENMILE CREEK LANCASTER, TEXAS SECTION 14

EMERGENCY STREAMBANK EROSION PROTECTION

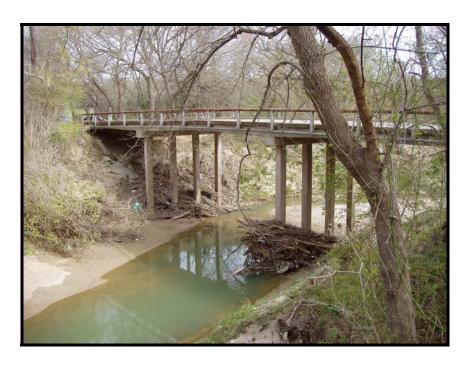
Photo 1: View of Nokomis Road bridge and Tenmile Creek from upstream.

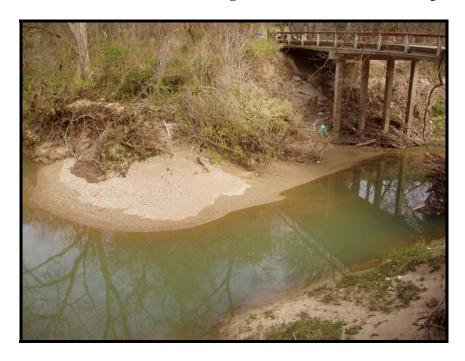
Photo 2: View of bend in Tenmile Creek immediately upstream of bridge.

Erosion is occurring upstream and downstream of the Nokomis Road bridge. Tenmile Creek in this area flows from the north, turns 90° to the left, passes under the bridge, then turns another 45° to the left (see Figure 3). Table 1 shows the typical velocities for this segment of Tenmile Creek.

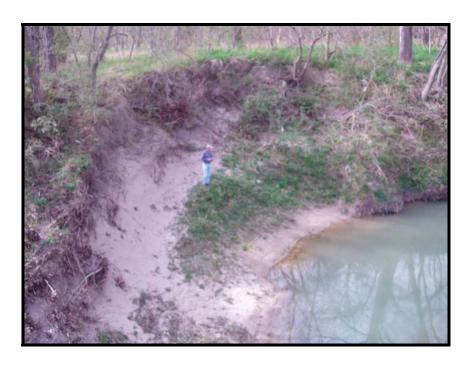
Photo 3: View of streambank erosion in vicinity of the bridge.

These velocities, combined with the hairpin turn of the creek have caused severe erosion upstream and downstream of the bridge. See the photographs in Appendix A for the current state of erosion in the area.

Stabilization is necessary where the creek has severely eroded under the Nokomis Road bridge and in the tight S- curves of the creek at that location (see Photos). Stabilization will be achieved through the use of gabion lining along both banks. The project boundary is limited to within 250 feet upstream and 250 feet downstream of the Nokomis Road bridge and approximately 400 feet in width across the existing channel. Construction impacts are not expected to extend this entire distance.

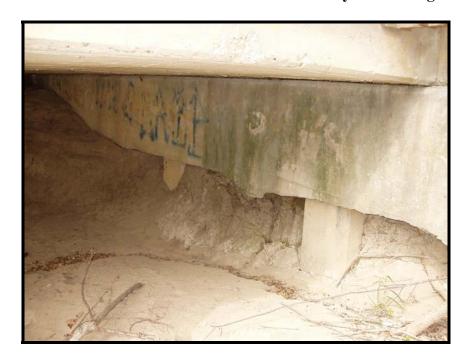
Photo 4: View of the foundation damage under the bridge.

Based on the field investigation, erosion calculations, and visual inspections, if erosion is not stabilized, the stream banks will continue to fail. At the current rate of erosion, both the embankment and the bridge for Nokomis Road are likely to be negatively impacted within the next five years.
